Manhole Inspection Summary

Manhole # S23K1_005MH

Insp Date: **11/25/08 2:08 PM**

Location Address: **4746 Marbourne Ave.**

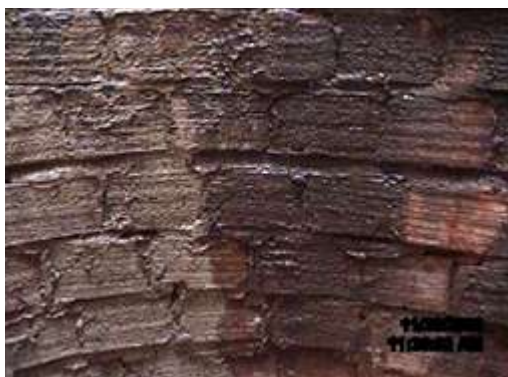
Defect 5

Infiltration: ☐ None ☒ **Joint** ☒ **Cracks** ☐ Mortar ☐ Roots ☒ **Wall**

barrel infiltration

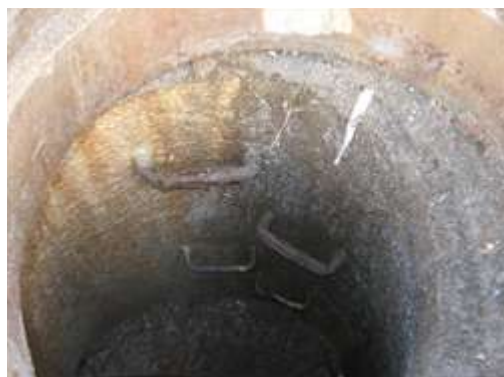
Defect 4

Steps Count: **5** Missing: **0** ☒ **Corroded**

corroded steps and chimney, corbel and barrel infiltration

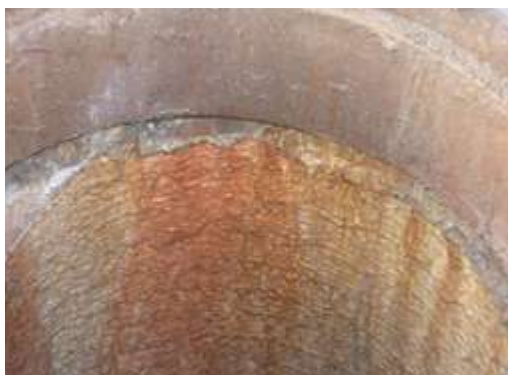
Defect 3

Infiltration: ☐ None ☒ **Joint** ☐ Cracks ☒ **Mortar** ☐ Roots ☐ Wall

Infiltration: ☐ None ☒ **Joint** ☐ Cracks ☐ Mortar ☐ Roots ☒ **Wall**

chimney flow joint, mineral build-up on corbel wall

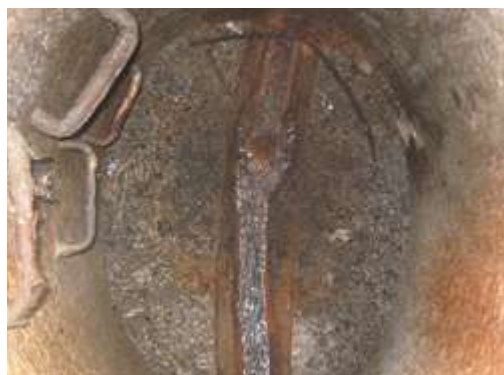
Defect

Condition: ☐ Sound ☐ Cracked ☐ Root Intrusion ☒ **Deteriorated** ☐ Leaks ☐ Debris

bench condition deteriorated

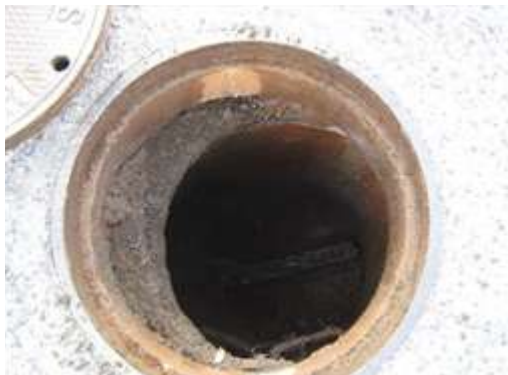
Defect 1

Frame Offset: **4** (in.) Condition: ☒ Sound ☐ Cracked ☐ Leaks

frame offset

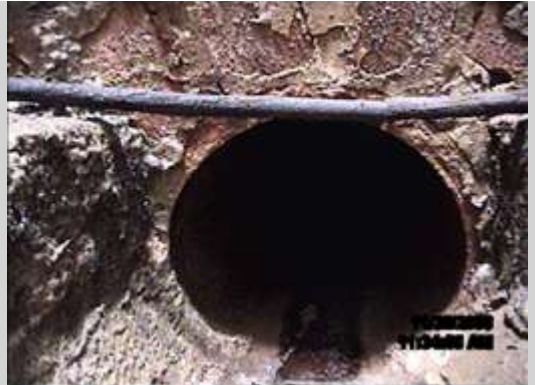
12 O'Clock Outflow

8 in. Circular Gravity Sewer
Pipe Out @ 12 O'Clock

Pipe Height: **8.4** (in.) Rod and Bar (Angled)
Pipe Material: **Clay** ☐ Pipe Lined
Invert Depth: **8.65** (ft.) Flow Characteristics: **Fast**
Deposits: ☒ None ☐ Mud ☐ Sludge ☐ Debris ☐ Grease
Silt Depth: **0** (in.) Deposits Extent:
Infiltration: **None** Pipe Seal Cond: **Sound**

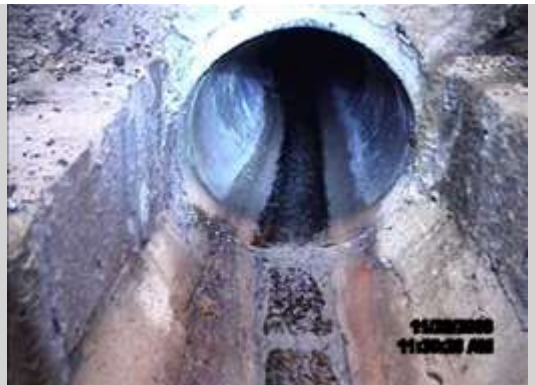
6 O'Clock Inflow

8 in. Circular Gravity Sewer
Pipe In @ 6 O'Clock

Pipe Height: **8.4** (in.) Rod and Bar (Angled)
Pipe Material: **Clay** ☐ Pipe Lined
Invert Depth: **8.26** (ft.) Flow Characteristics: **Fast**
Deposits: ☒ None ☐ Mud ☐ Sludge ☐ Debris ☐ Grease
Silt Depth: **0** (in.) Deposits Extent:
Infiltration: **None** Pipe Seal Cond: **Sound**
